PERFORMANCE TEST REPORT

- APPARATUS : Lithium primary battery(Li/SOCL₂)
- VOLTAGE RATINGS : 3.65V
- APPLIED STANDARD : IEC62281 (Edition 4.0)/UN 38.3(7th Edition)
- TYPE OF BATTERY : LITHIUM METAL BATTERY

- MASS : 95.0g
- LITHIUM METAL CONTENT PER CELL : 5g
- PHYSICAL DESCRIPTION OF CELL(BATTERY) : CYLINDRICAL CELL
- MODEL NAME : SB-D02
- MANUFACTURER INFO.: Name of the company : VITZROCELL
 ADDRESS : 70, Indusparkro, Hapdeok-eup, Dangjin-si, Chung-Nam, S.KOREA
 TEL : 82 02 2024 3244,
 Web : www.vitzrocell.com / Email : overseas@vitzrocell.com

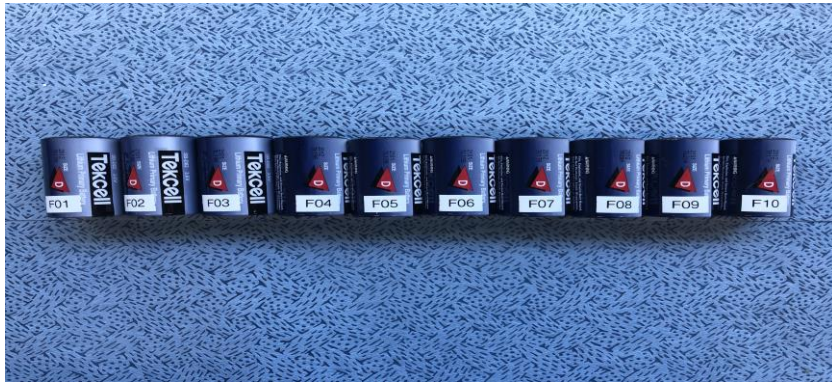
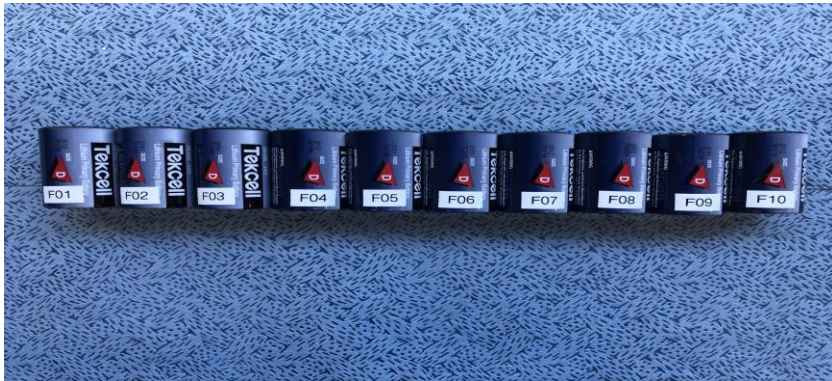
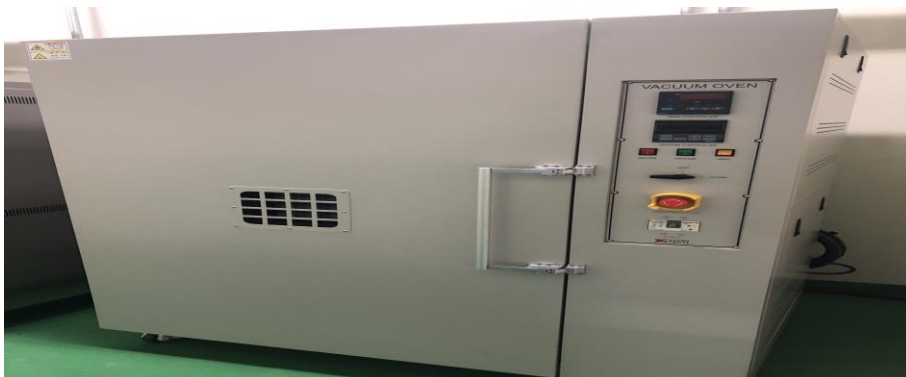
Photo.01 – Photographs of specimen before & after Altitude simulation test (Undischarged cells)

Photographs of specimen before test

Photographs of specimen after test

#01	Un-Discharged Cells	[Test Procedure] Test cells were stored at a pressure of 11.6kPa for 6hours at ambient temperature (20±5℃) [Requirement] -NM / NL / NV / NC / NE / NR / NF -Open circuit voltage of the test cell after test : not less than 90% of its voltage prior to this test	3.680	3.680	95.58	95.58	* NM NL NV NC NE NR NF (PASS)	Ph.01

#02			3.683	3.683	95.24	95.24		Ph.01
#03			3.682	3.682	95.34	95.34		Ph.01
#04			3.678	3.678	94.99	94.99		Ph.01
#05			3.682	3.682	95.41	95.41		Ph.01
#06			3.684	3.684	95.37	95.37		Ph.01

#07			3.686	3.686	95.32	95.32		Ph.01
#08			3.686	3.686	95.05	95.05		Ph.01
#09			3.683	3.683	95.25	95.25		Ph.01
#10			3.680	3.680	94.97	94.97		Ph.01
#11	Fully Discharged Cells	[Test Procedure] Test cells were stored at a pressure of 11.6kPa for 6hours at ambient temperature (20±5℃) [Requirement] -NM / NL / NV / NC / NE / NR / NF	-	-	95.86	95.86	* NM NL NV NC NE NR NF (PASS)	Ph.02

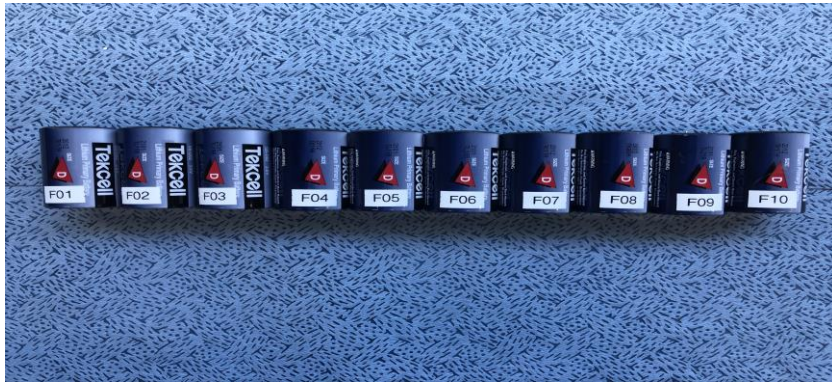
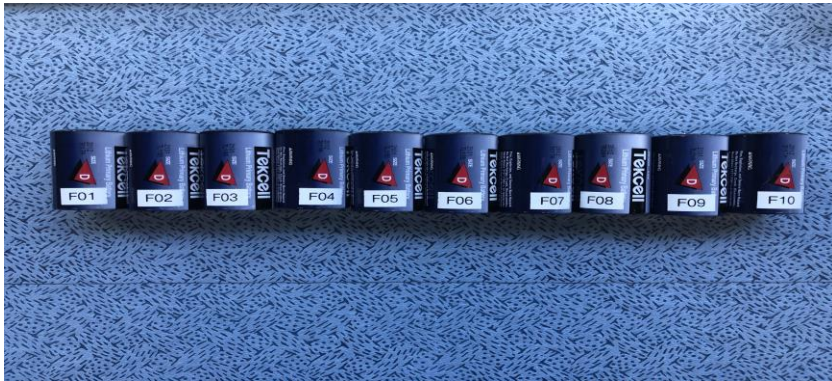
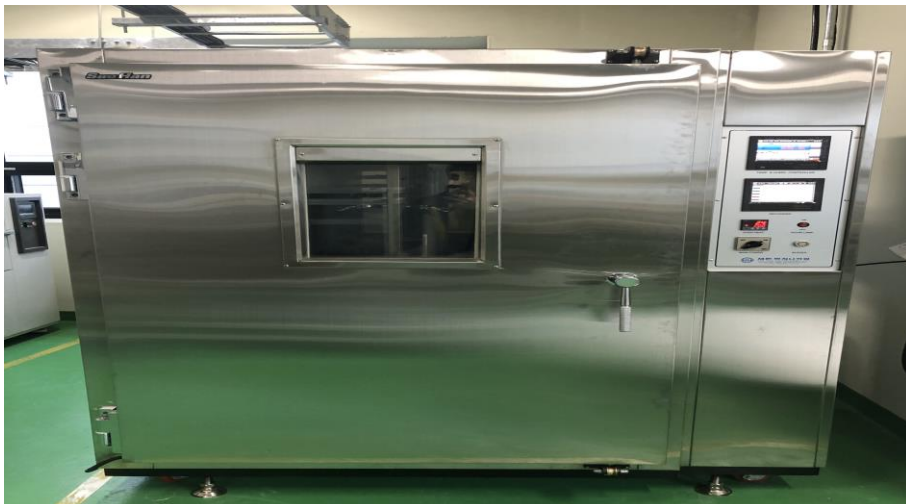
Photo.03 – Photographs of specimen before & after Thermal test (Undischarged cells)

Photographs of specimen before test

Photographs of specimen after test

#01	Un-Discharged Cells	[Test Procedure] Test cells were stored for 6hours at 72±2°C, followed by storage for 6hours at -40±2°C. The maximum time interval between test temperature extreme was 30minutes. This procedure was repeated 10times, after which all test cells were stored for 24hours at ambient temperature (20±5°C) [Requirement] - NM / NL / NV / NC / NE / NR / NF - Open circuit voltage of the test cell after test : not less than 90% of its voltage prior to this test	3.680	3.714	95.58	95.57	* NM NL NV NC NE NR NF (PASS)	Ph.03

#02			3.683	3.710	95.24	95.24		Ph.03
#03			3.682	3.712	95.34	95.34		Ph.03
#04			3.678	3.714	94.99	94.98		Ph.03
#05			3.682	3.706	95.41	95.41		Ph.03
#06			3.684	3.734	95.37	95.37		Ph.03

#07			3.686	3.712	95.32	95.31		Ph.03
#08			3.686	3.708	95.05	95.05		Ph.03
#09			3.683	3.702	95.25	95.25		Ph.03
#10			3.680	3.711	94.97	94.96		Ph.03
#11	Fully Discharged Cells	[Test Procedure] Test cells were stored for 6hours at 72±2°C, followed by storage for 6hours at -40±2°C. The maximum time interval between test temperature extreme was 30minutes. This procedure was repeated 10times, after which all test cells were stored for 24hours at ambient temperature (20±5°C) [Requirement] -NM / NL / NV / NC / NE / NR / NF	-	-	95.86	95.85	* NM NL NV NC NE NR NF (PASS)	Ph.04

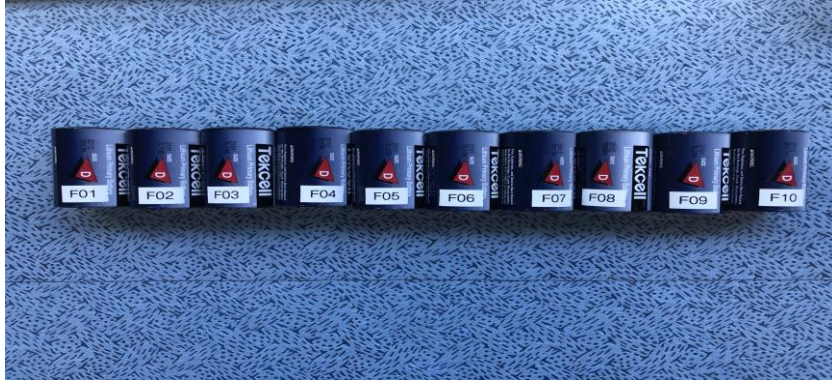
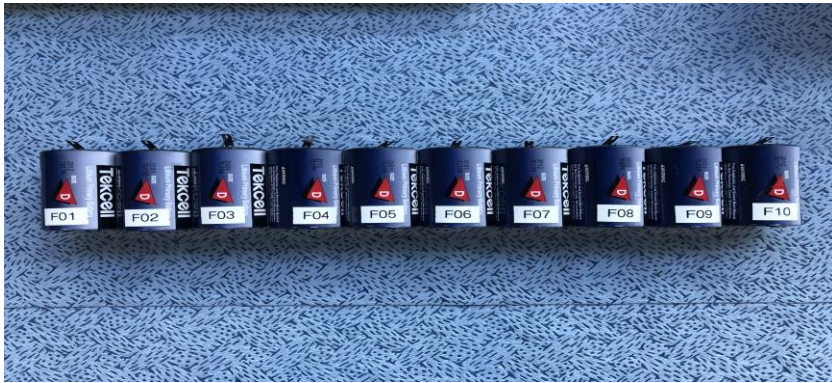
Photo.05 – Photographs of specimen before & after Vibration test (Undischarged cells)

Photographs of specimen before test

Photographs of specimen after test

#01	Un-Discharged Cells	[Test Procedure] Cells were firmly secured to the platform of the vibration machine. The vibration was a sinusoidal waveform with a logarithmic sweep between 7Hz and 200Hz and back to 7Hz traversed in 15minutes. This cycle was repeated 12times for a total of 3hours for each of 3mutua-ly perpendicular mounting positions of the cells. •Frequency,Acceleration and amplitude - 7~18Hz : 1G - 18~50Hz : 1~8G(1.6mm p-p) - 50~200Hz : 8G [Requirement] - NM / NL / NV / NC / NE / NR / NF - Open circuit voltage of the test cell after test : not less than 90% of its voltage prior to this test	3.714	3.685	95.57	95.57	* NM NL NV NC NE NR NF (PASS)	Ph.05

#02			3.710	3.678	95.24	95.24		Ph.05
#03			3.712	3.682	95.34	95.34		Ph.05
#04			3.714	3.681	94.98	94.98		Ph.05
#05			3.706	3.675	95.41	95.41		Ph.05
#06			3.734	3.702	95.37	95.37		Ph.05

#07			3.712	3.695	95.31	95.31		Ph.05
#08			3.708	3.685	95.05	95.05		Ph.05
#09			3.702	3.689	95.25	95.25		Ph.05
#10			3.711	3.685	94.96	94.96		Ph.05
#11	Fully Discharged Cells	[Test Procedure] Cells were firmly secured to the platform of the vibration machine. The vibration was a sinusoidal waveform with a logarithmic sweep between 7Hz and 200Hz and back to 7Hz traversed in 15minutes. This cycle was repeated 12times for a total of 3hours for each of 3mutua-ly perpendicular mounting positions of the cells. •Frequency,Acceleration and amplitude - 7~18Hz : 1G - 18~50Hz : 1~8G(1.6mm p-p) - 50~200Hz : 8G [Requirement] - NM / NL / NV / NC / NE / NR / NF	-	-	95.85	95.85	* NM NL NV NC NE NR NF (PASS)	Ph.06

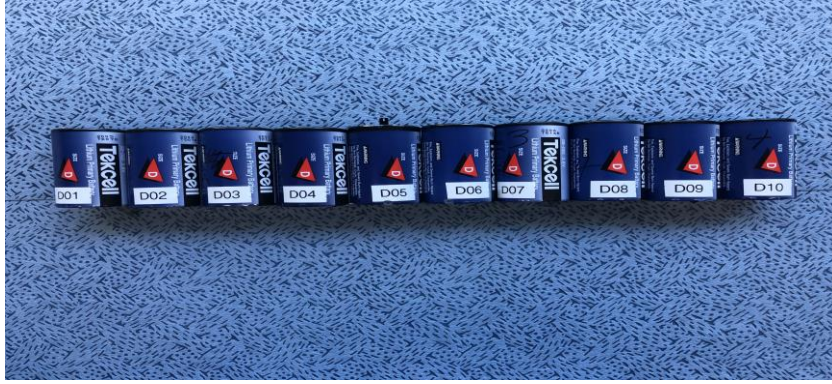
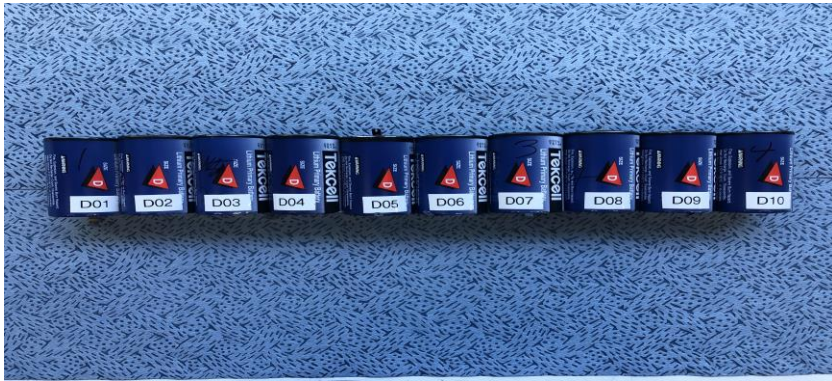
Photo.06 – Photographs of specimen before & after Vibration test (Fully discharged cells)

Photographs of specimen before test

Photographs of specimen after test

#12			-	-	94.82	94.82		Ph.06
#13			-	-	94.96	94.96		Ph.06
#14			-	-	95.59	95.59		Ph.06
#15			-	-	95.54	95.54		Ph.06
#16			-	-	94.99	94.99		Ph.06
#17			-	-	95.00	95.00		Ph.06

#18			-	-	94.40	94.40		Ph.06
#19			-	-	94.91	94.91		Ph.06
#20			-	-	95.84	95.84		Ph.06

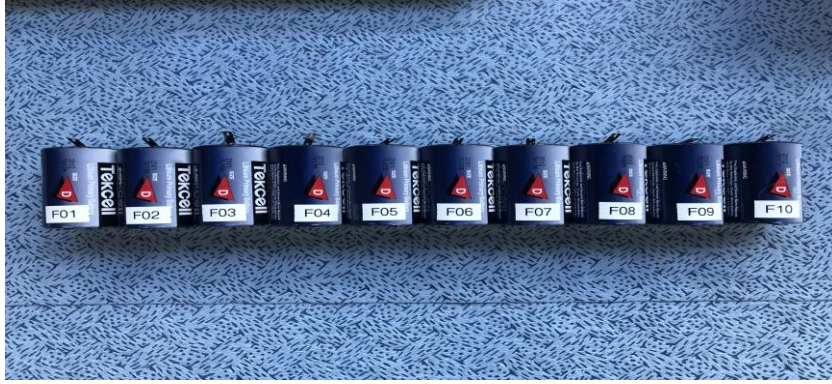
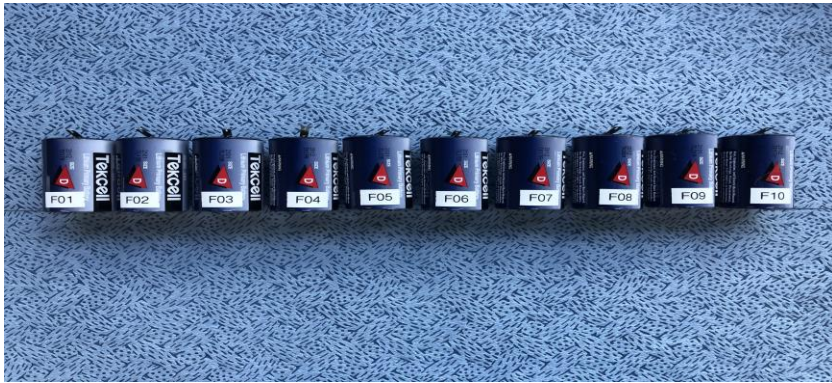
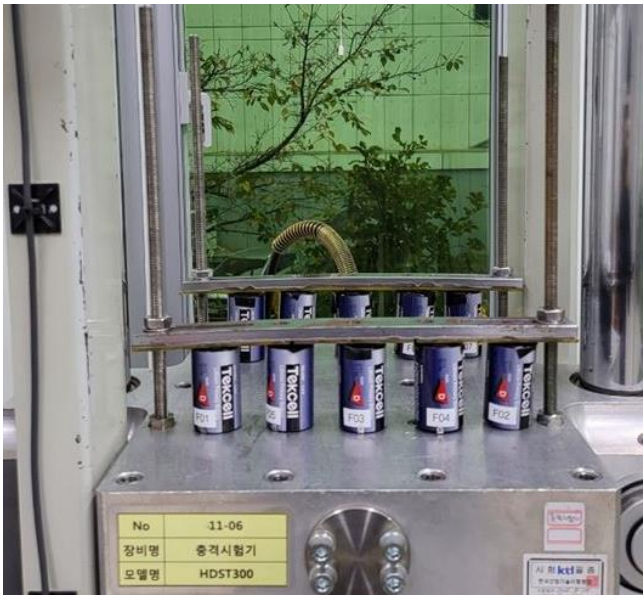
Photo.07 – Photographs of specimen before & after Shock test (Undischarged cells)

Photographs of specimen before test

Photographs of specimen after test

#01	Un-Discharged Cells	[Test Procedure] Each test cell was subjected to a halfsine shock of peak acceleration of 150g _n and pulse duration of 6ms. Each cell was subjected to 3shocks in the positive direction followed by 3 shocks in the negative direction of 3mutually perpendicular mounting positions of the cell for a total of 18 shock. [Requirement] – NM / NL / NV / NC / NE / NR / NF – Open circuit voltage of the test cell after test : not less than 90% of its voltage prior to this test	3.685	3.685	95.57	95.57	* NM NL NV NC NE NR NF (PASS)	Ph.07

#02			3.678	3.678	95.24	95.24		Ph.07
#03			3.682	3.682	95.34	95.34		Ph.07
#04			3.681	3.681	94.98	94.98		Ph.07
#05			3.675	3.675	95.41	95.41		Ph.07
#06			3.702	3.702	95.37	95.37		Ph.07

#07			3.695	3.695	95.31	95.31		Ph.07
#08			3.685	3.685	95.05	95.05		Ph.07
#09			3.689	3.689	95.25	95.25		Ph.07
#10			3.685	3.685	94.96	94.96		Ph.07
#11	Fully Discharged Cells	[Test Procedure] Each test cell was subjected to a halfsine shock of peak acceleration of 150g _n and pulse duration of 6ms. Each cell was subjected to 3shocks in the positive direction followed by 3 shocks in the negative direction of 3mutually perpendicular mounting positions of the cell for a total of 18 shock. [Requirement] – NM / NL / NV / NC / NE / NR / NF	–	–	95.85	95.85	* NM NL NV NC NE NR NF (PASS)	Ph.08

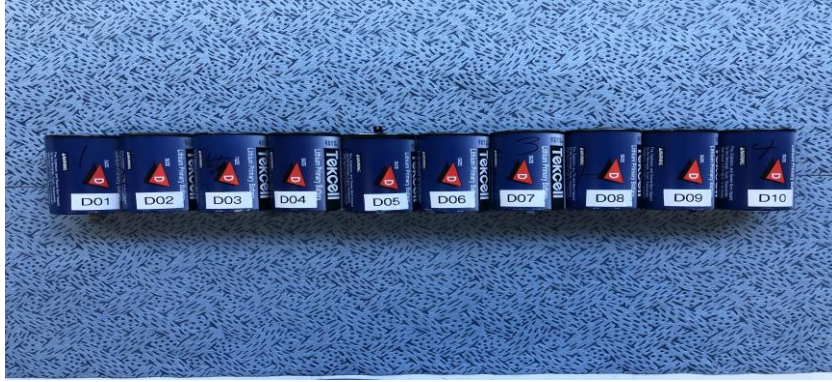
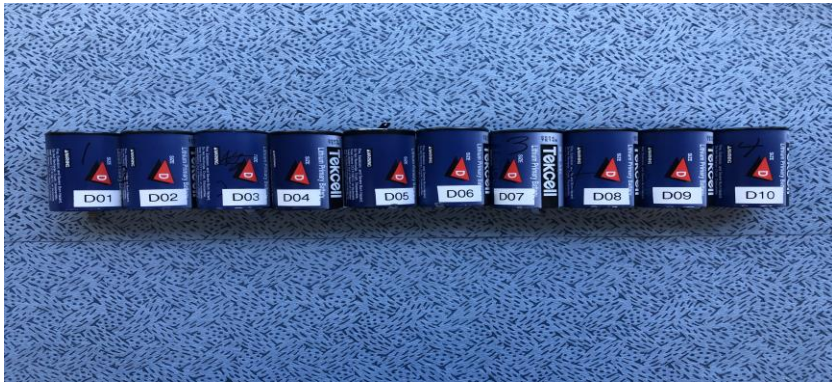
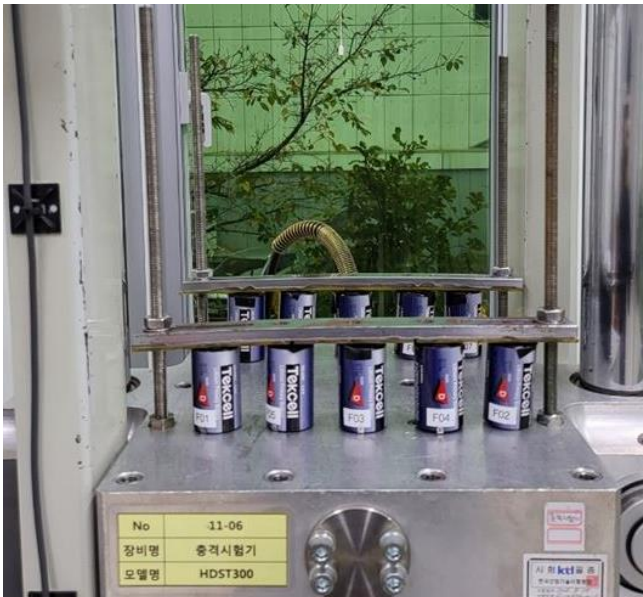
Photo.08 – Photographs of specimen before & after Shock test (Fully discharged cells)

Photographs of specimen before test

Photographs of specimen after test

#12			–	–	94.82	94.82		Ph.08
#13			–	–	94.96	94.96		Ph.08
#14			–	–	95.59	95.59		Ph.08
#15			–	–	95.54	95.54		Ph.08
#16			–	–	94.99	94.99		Ph.08
#17			–	–	95.00	95.00		Ph.08

#18			–	–	94.40	94.40		Ph.08
#19			–	–	94.91	94.91		Ph.08
#20			–	–	95.84	95.84		Ph.08

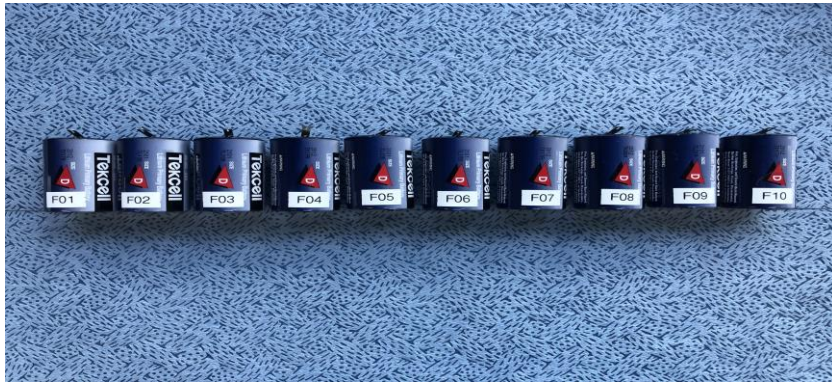
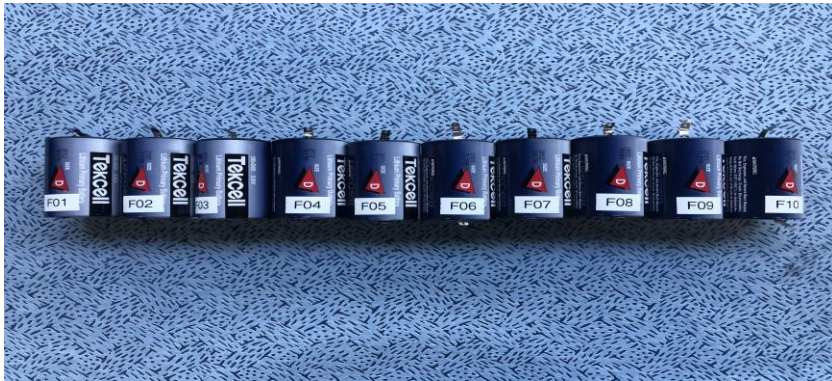
Photo.09 – Photographs of specimen before & after External short circuit test (Undischarged cells)

Photographs of specimen before test

Photographs of specimen after test

Specimen No.	State of charge	Test procedure & requirement	Max. Temperature of during test(°C)	Result	Photo
#01	Un-Discharged Cells	[Test Procedure] Test cells were subjected to a short circuit condition with a total external resistance of less than 0.1Ω at 57±4°C. The test has been continued for 1hour after the cell external case temperature has returned to 57±4°C. Test cell was observed for a further 6hours. [Requirement] - NE / NR / NF - External temperature of the cell ≤ 170°C (NT)	91.3	* NT NE NR NF (PASS)	Ph.09

#02			87.8		Ph.09
#03			88.0		Ph.09
#04			83.2		Ph.09
#05			82.5		Ph.09
#06			75.0		Ph.09
#07			85.6		Ph.09
#08			86.9		Ph.09
#09			85.0		Ph.09
#10			86.4		Ph.09

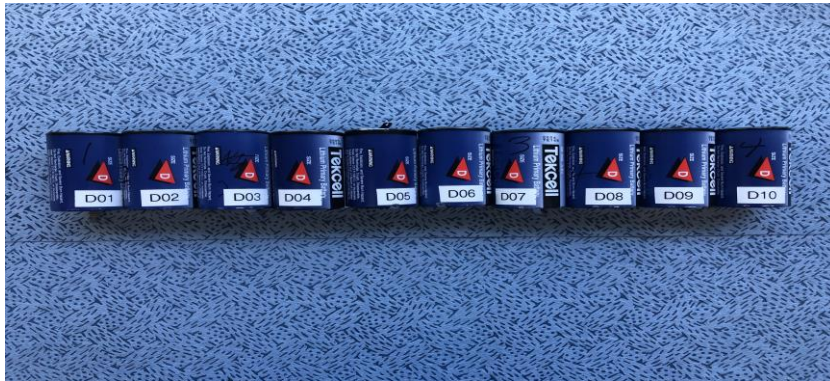
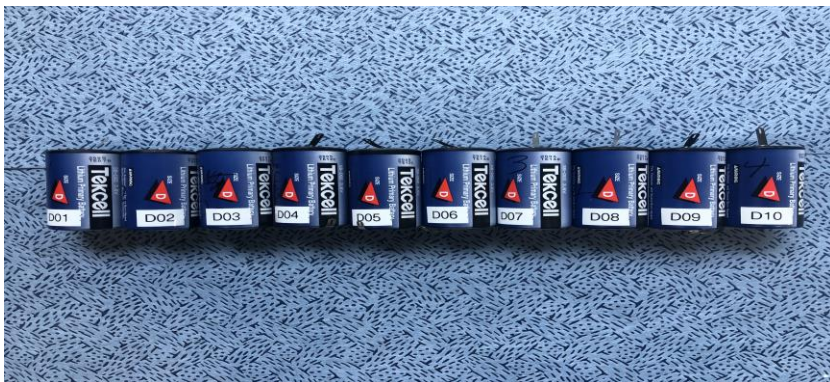
Photo.10 – Photographs of specimen before & after External short circuit test (Fully discharged cells)

Photographs of specimen before test

Photographs of specimen after test

#11	Fully Discharged Cells	[Test Procedure] Test cells were subjected to a short circuit condition with a total external resistance of less than 0.1Ω at 57±4°C. The test has been continued for 1hour after the cell external case temperature has returned to 57±4°C. Test cell was observed for a further 6hours. [Requirement] - NE / NR / NF - External temperature of the cell ≤ 170°C (NT)	58.5	* NT NE NR NF (PASS)	Ph.10

#12			59.4		Ph.10
#13			61.3		Ph.10
#14			58.7		Ph.10
#15			57.7		Ph.10
#16			59.2		Ph.10
#17			58.9		Ph.10
#18			58.0		Ph.10
#19			60.4		Ph.10
#20			58.4		Ph.10

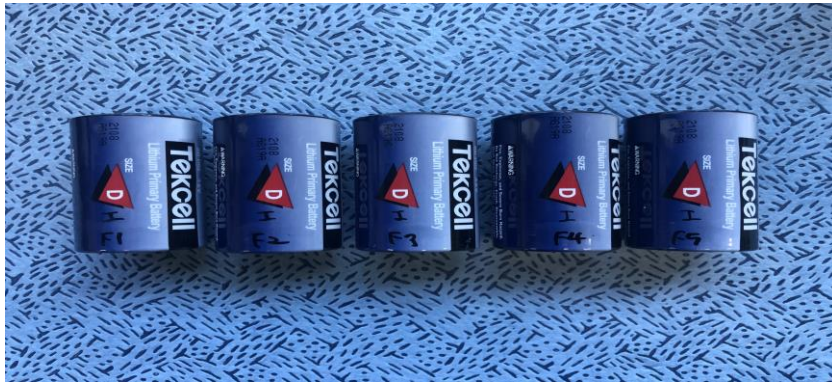
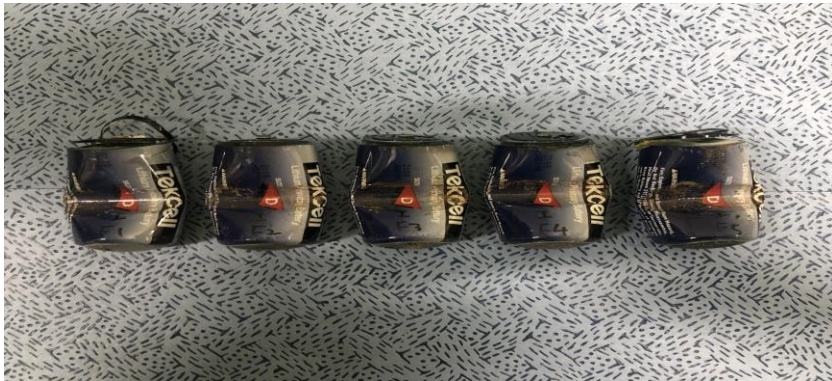
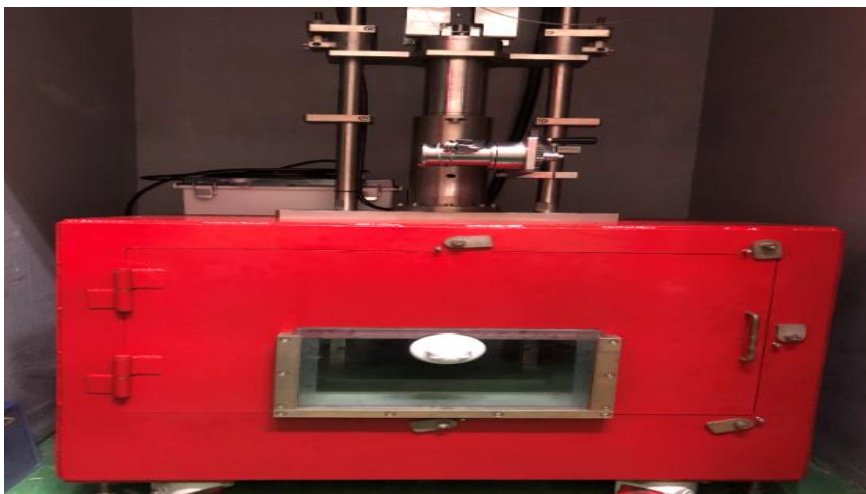
Photo.11 – Photographs of specimen before & after Impact test (Undischarged cells)

Photographs of specimen before test

Photographs of specimen after test

Specimen No.	State of charge	Test procedure & requirement	Max. Temperature of during test(°C)	Result	Photo
#21	Un-Discharged Cells	[Test Procedure] A 15.8mm diameter bar was placed across the center of the fully charged cells. Then 9.1kg weight was dropped from a height of 61cm onto cells. [Requirement] - NE / NF - External temperature of the cell ≤ 170°C (NT)	26.1	* NT NE NF (PASS)	Ph.11
#22			27.6		Ph.11
#23			25.9		Ph.11
#24			26.7		Ph.11
#25			25.5		Ph.11
#26	Fully Discharged Cells	[Test Procedure] A 15.8mm diameter bar was placed across the center of the fully discharged cells. Then 9.1kg weight was dropped from a height of 61cm onto cells. [Requirement] - NE / NF - External temperature of the cell ≤ 170°C (NT)	25.7	* NT NE NF (PASS)	Ph.12
#27			26.4		Ph.12
#28			25.8		Ph.12
#29			25.8		Ph.12
#30			25.7		Ph.12

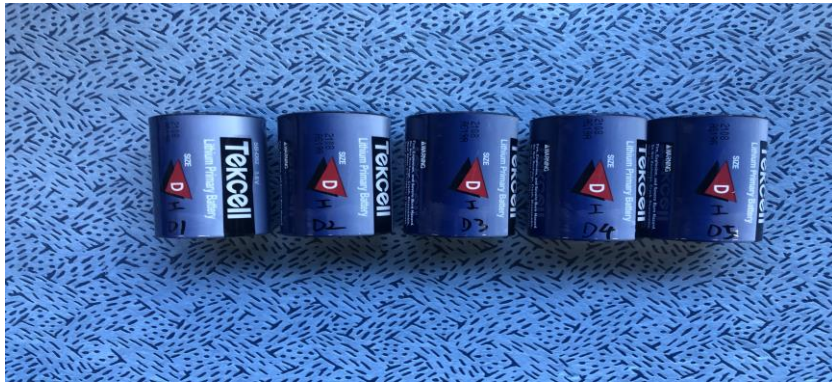
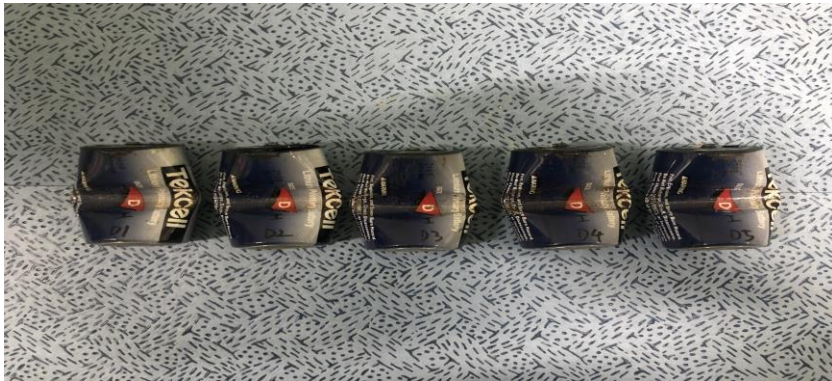
Photo.12 – Photographs of specimen before & after Impact test (Fully discharged cells)

Photographs of specimen before test

Photographs of specimen after test

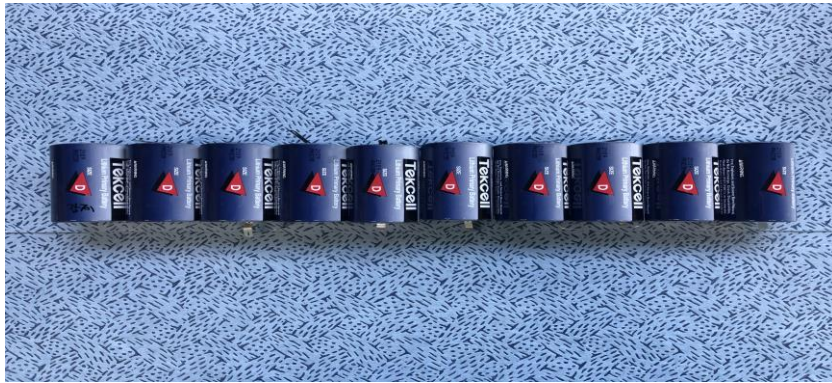
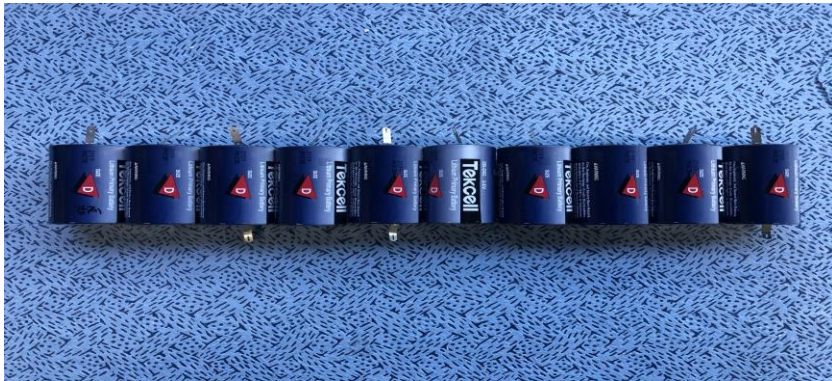
Photo.13 – Photographs of specimen before & after Forced discharge test (Fully discharged cells)

Photographs of specimen before test

Photographs of specimen after test

[Discharge condition : 100mA/ 190hours]

Specimen No.	State of charge	Test procedure & requirement	Result	Reference
#31	Fully Discharged Cells	[Test Procedure] Each cell shall be forced discharged at ambient temperature by connecting it in series with a 12V direct current power supply at an initial current equal to the maximum continuous discharge current specified by the manufacturer [Requirement] - NE / NF	* NE NF (PASS)	Ph.13/Graph1
#32				Ph.13/Graph1
#33				Ph.13/Graph1
#34				Ph.13/Graph1
#35				Ph.13/Graph1
#36				Ph.13/Graph1
#37				Ph.13/Graph1
#38				Ph.13/Graph1
#39				Ph.13/Graph1
#40				Ph.13/Graph1
